Intel[®] Pentium[®] 4 Processor Specification Update

Release Date: March 2002

The Intel[®] Pentium[®] 4 processor may contain design defects or errors known as errata which may cause the product to deviate from published specifications. Current characterized errata are documented in this Specification Update.

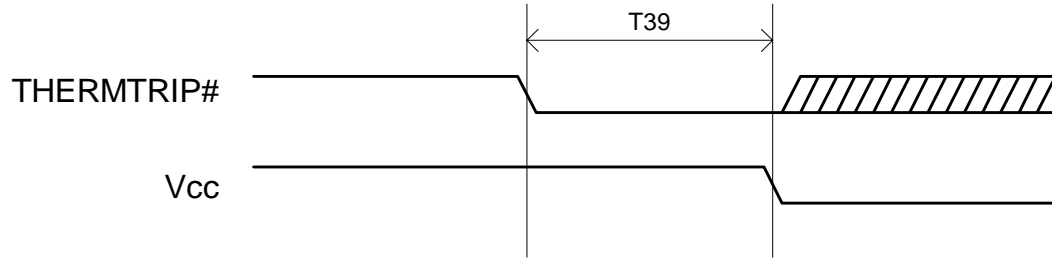
The following figure will be added as Figure (new). THERMTRIP# Power Down Sequence

<u>T# Parameter</u>	<u>Min</u>	<u>Max</u>	<u>Unit</u>	<u>Figure</u>	<u>Notes</u>
T39: THERMTRIP# to removal of power	N/A	500	ms	(new)

$T39 < 0.5$ seconds

Note: THERMTRIP# is undefined when RESET# is active

Assertion of THERMTRIP# (Thermal Trip) indicates the processor junction temperature has reached a level beyond which permanent silicon damage may occur. Measurement of the temperature is accomplished through an internal thermal sensor which is configured to trip at approximately 135°C. Upon assertion of THERMTRIP#, the processor will shut off its internal clocks (thus halting program execution) in an attempt to reduce the processor junction temperature. To protect the processor, its core voltage (V_{CC}) must be removed following the assertion of THERMTRIP#. See Figure (new) and Table 13 for the appropriate power down sequence and timing requirements. Once activated, THERMTRIP# remains latched until RESET# is asserted. While the assertion of the RESET# signal will de-assert THERMTRIP# , if the processor's junction temperature remains at or above the trip level, THERMTRIP# will again be asserted after RESET# is de-asserted.
